INDOOR AIR QUALITY ASSESSMENT

**Department of Social Services
24 Farnsworth Street
Boston, Massachusetts 02210**

Prepared by:
Massachusetts Department of Public Health
Center for Environmental Health
Emergency Response/Indoor Air Quality Program
November 2005

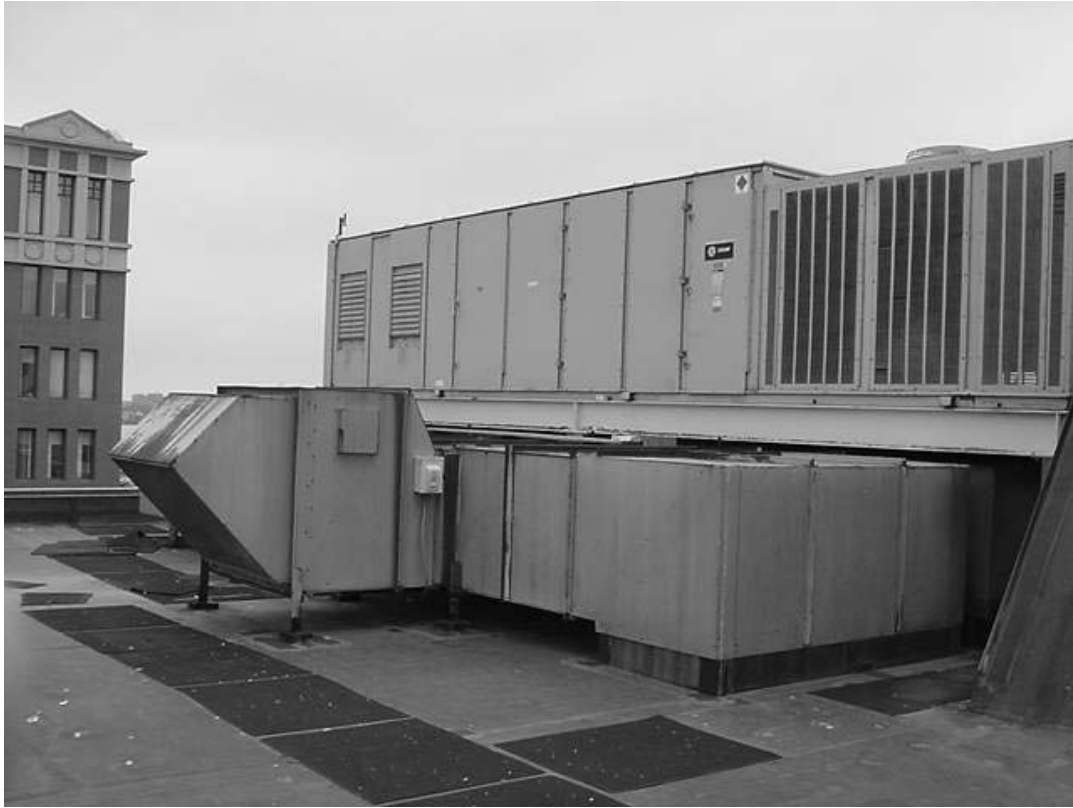
Picture 1

It can be seen from Table 1 that carbon dioxide levels were above 800 parts per million (ppm) in fifty-five of seventy-two areas the day of the assessment, indicating poor air exchange in the majority of areas surveyed. Ventilation is provided by a heating, ventilating and air conditioning (HVAC) system, which consists of rooftop air handling units (AHUs) ducted to ceiling-mounted supply and return vents (Pictures 1 through 4). This system was operating throughout the building during the assessment. However, it is important to note that the HVAC system limits outside air intake on hot, humid days to maintain cooling (as was the case during this assessment), (Picture 5). Limiting outside air intake can contribute to an increase in carbon dioxide levels.

Rooftop Air Handling Unit

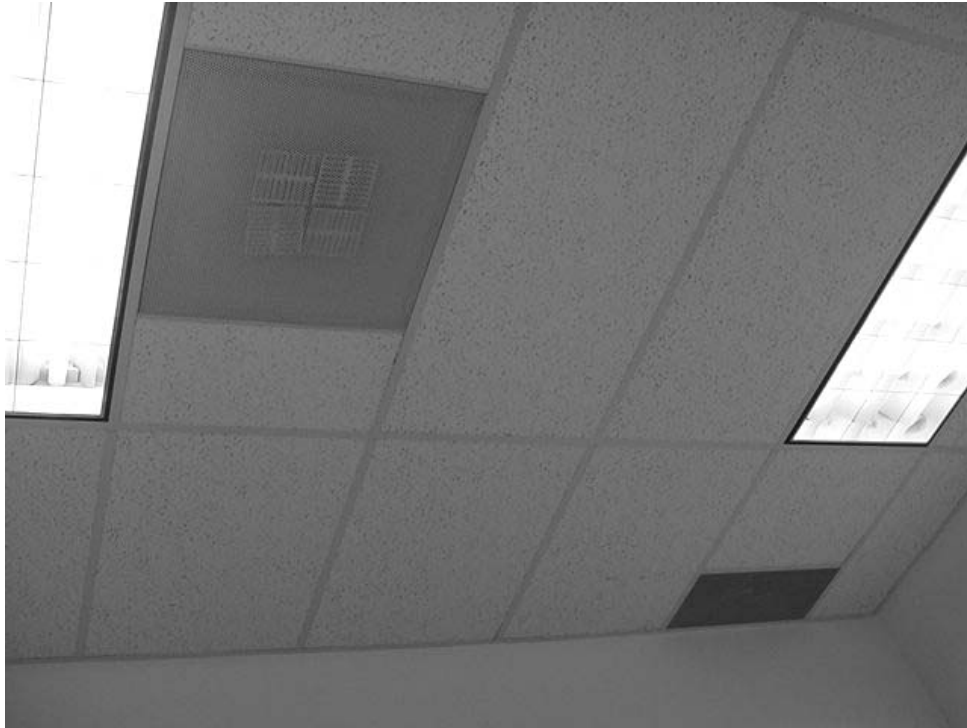
Picture 2

Ceiling-Mounted Supply and Return Vents

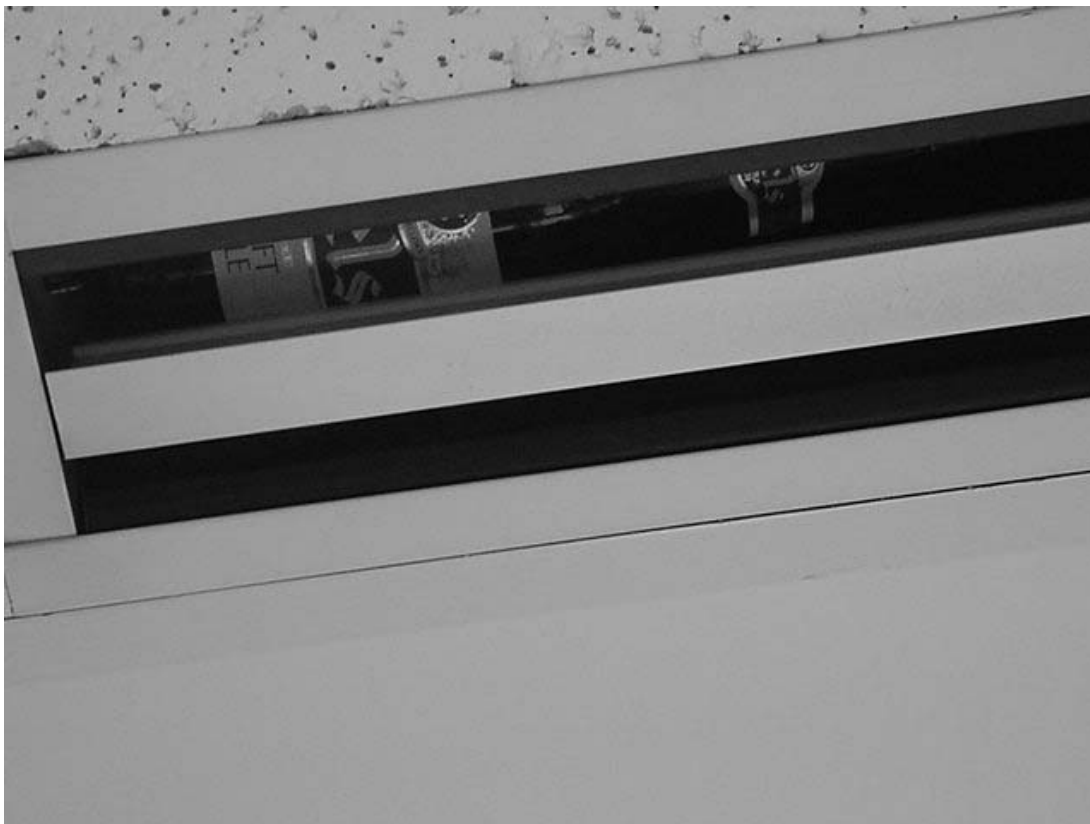
Picture 3

Slotted Ceiling-Mounted Supply Vent, Note Beer Bottle in Vent

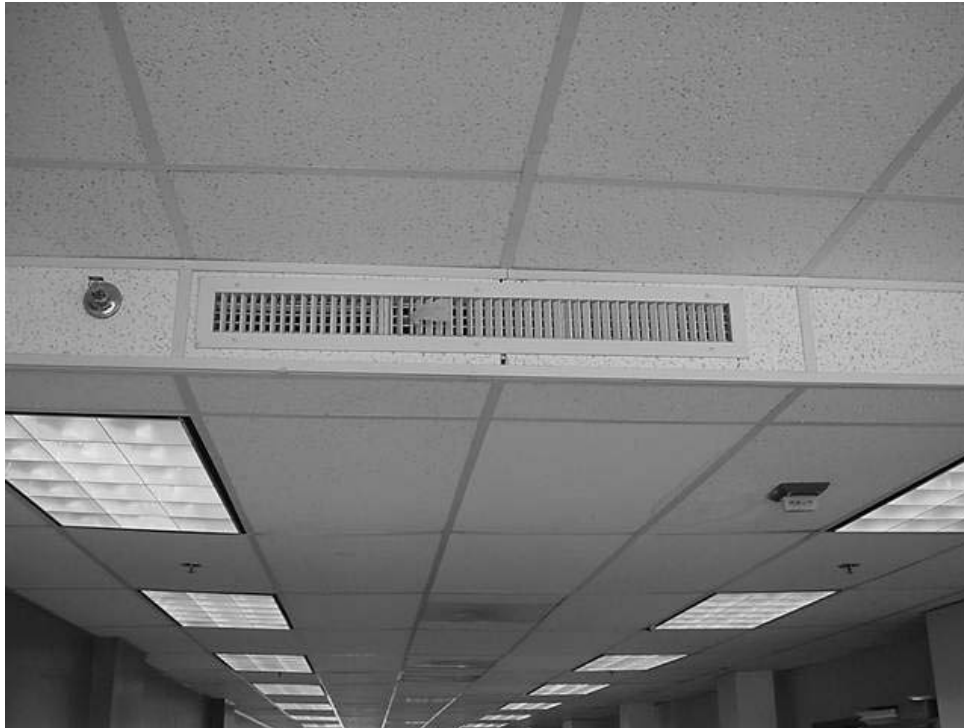
Picture 4

Ceiling-Mounted Supply Vent

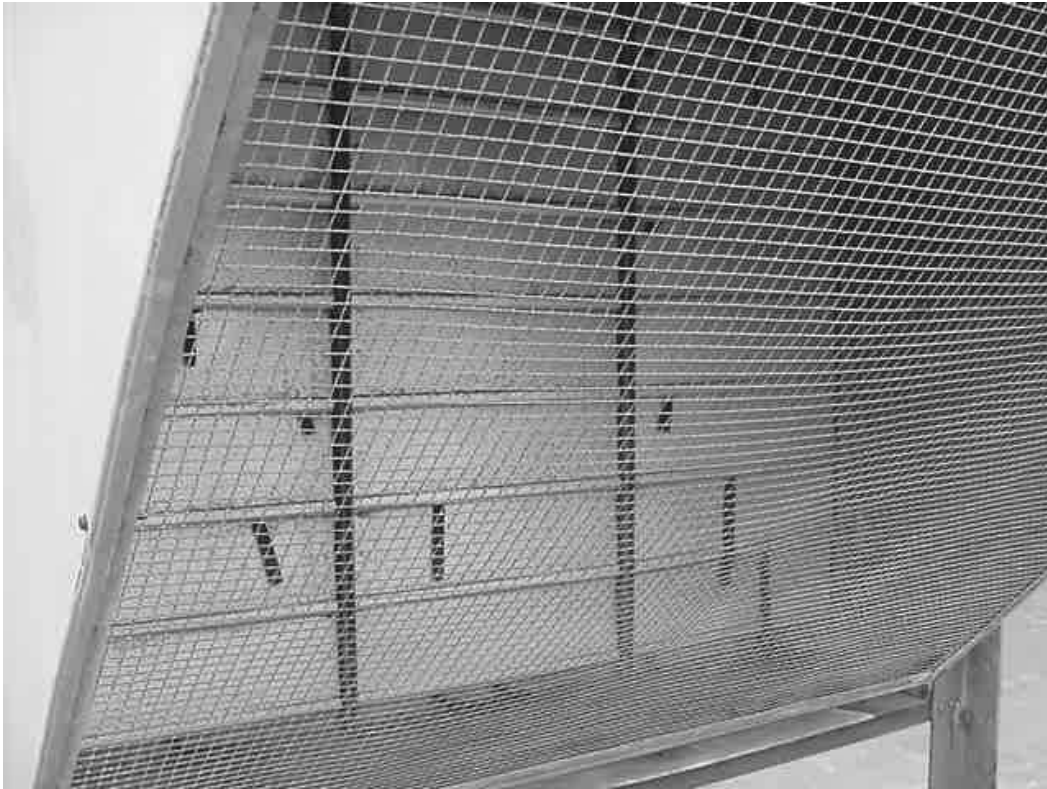
Picture 5

Rooftop AHU Supply Intake Louvers Shut, Limiting Airflow

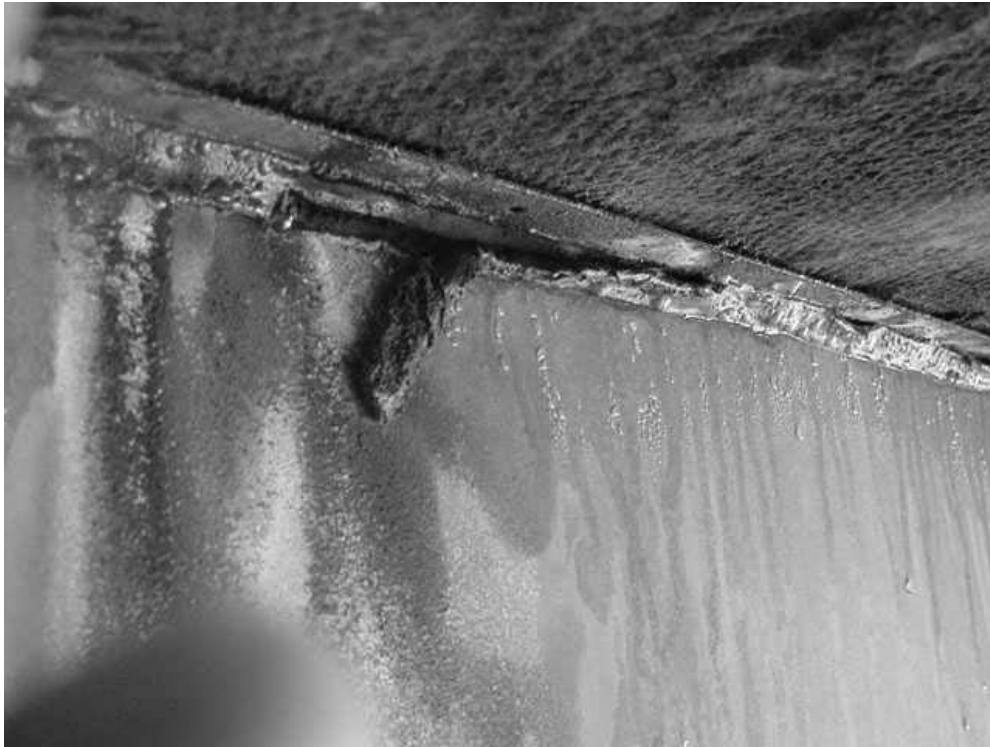
Picture 6

Open Seam Joints in Ductwork on Roof Where Conditioned Air was Escaping

1. Repair breaches in rooftop ductwork to prevent loss of conditioned air.
2. Consult a ventilation engineer concerning re-balancing of the ventilation systems. The Ventilation industrial standards recommend that mechanical ventilation systems be balanced every five years (SMACNA, 1994).
3. Encourage DSS staff to report any complaints concerning temperature control/preventive maintenance issues to the facilities department in order to help

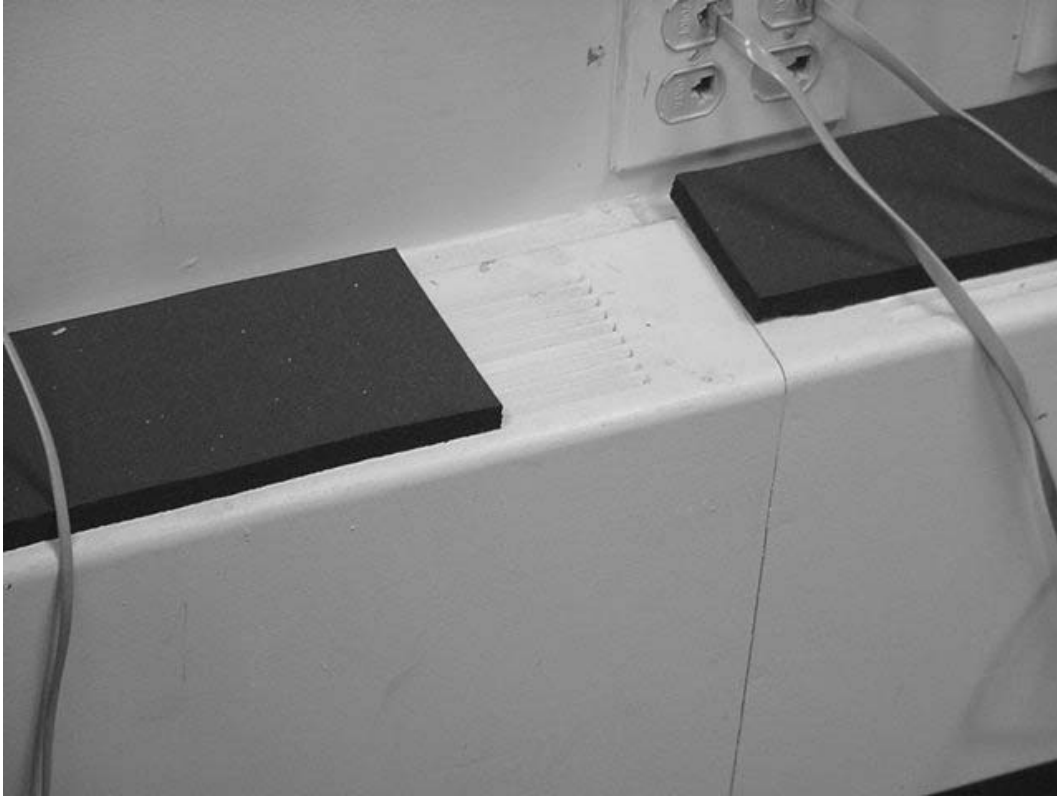
Picture 8

Temperature readings ranged from 72° F to 76° F, which were within the MDPH recommended comfort guidelines the day of the assessment. The MDPH recommends that indoor air temperatures be maintained in a range of 70° F to 78° F in order to provide for the comfort of building occupants. In many cases concerning indoor air quality, fluctuations of temperature in occupied spaces are typically experienced, even in a building with an adequate fresh air supply. Although temperatures were within the MDPH recommended comfort range on the day of the assessment, complaints of uneven heating and cooling were expressed by occupants in areas throughout the building. As a general rule, ductwork should be as airtight as possible. MDPH staff examined AHUs on the roof and found several breaches in the ductwork (Picture 6) where cold/conditioned air was escaping. These breaches can result in an unbalanced ventilation system, which can make it difficult to maintain temperature/comfort control. Extreme heat was reported in the IT/Help Desk area on the third floor. Occupants reported that radiant heat vents were blocked by building maintenance personnel in an attempt to reduce heat (Pictures 7 and 8).

Close-up of Blocked Radiant Heat Vents

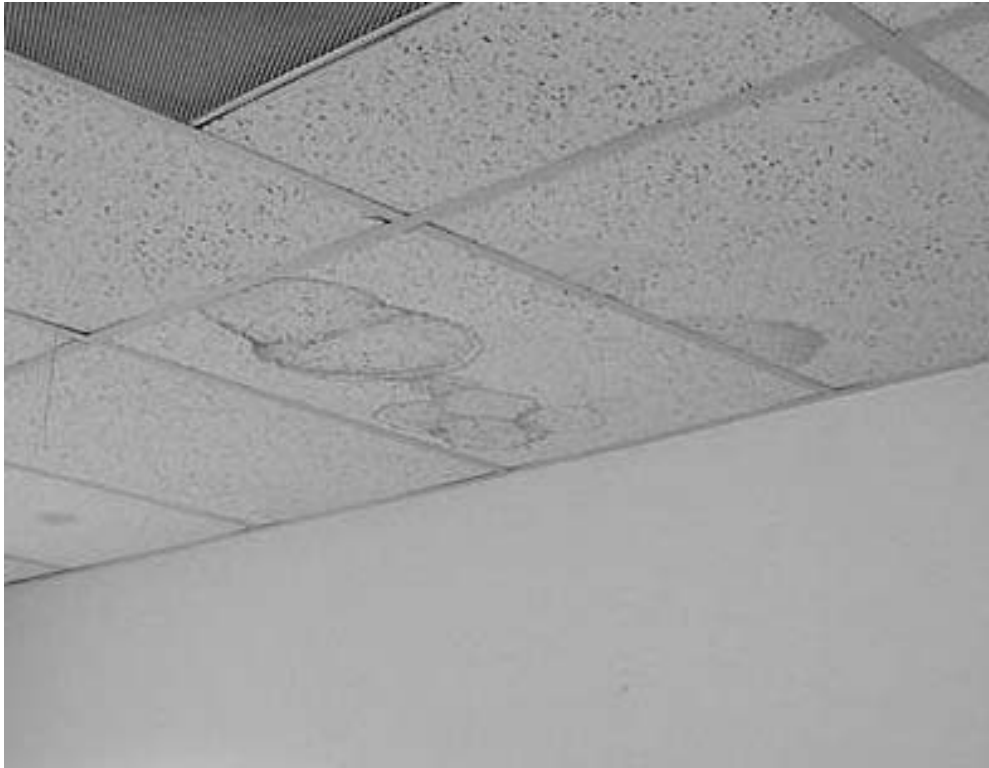
Picture 9

A few areas had water-damaged ceiling tiles (Picture 9). Water-damaged ceiling tiles can provide a source for mold and should be replaced after a moisture source or leak is discovered and repaired. Occupants reported chronic roof leaks in the Adoption Subsidy Unit (ASU) on the fourth floor, which is located under a concrete block deck (Picture 10). Although the roof is equipped with drains (Picture 11), it appears that water may accumulate due to the presence of heavy moss growth between concrete blocks (Picture 12).

readings were measured during the assessment (Table 1). In addition, a thorough visual examination of water-damaged materials was conducted. Although, signs of water damage were apparent, no visible mold growth or associated odors were observed and/or detected during the assessment.

Water Damaged Ceiling Tiles, 4th Floor Adoption Subsidy Unit

5. Replace water-damaged ceiling tiles. Examine the non-porous surface beneath the removed ceiling tiles and disinfect with an appropriate antimicrobial. Appropriate measures should also be taken to minimize the aerosolization of particulates from tile removal/replacement.

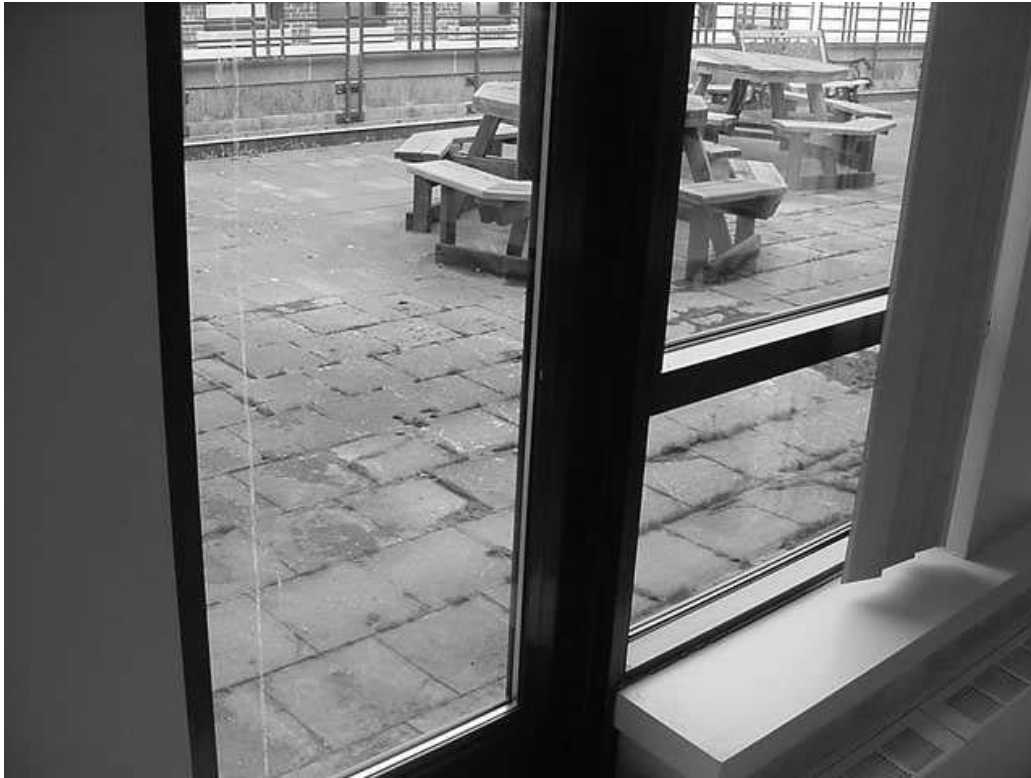
Picture 10

Concrete Block Deck over 4th Floor, Accessible from Cafeteria on 5th Floor

7. Consider consult with an architect, masonry firm or general contractor regarding the integrity of the building envelope, primarily concerning water penetration through the fifth floor roof deck. Ensure proper drainage, make repairs as needed.

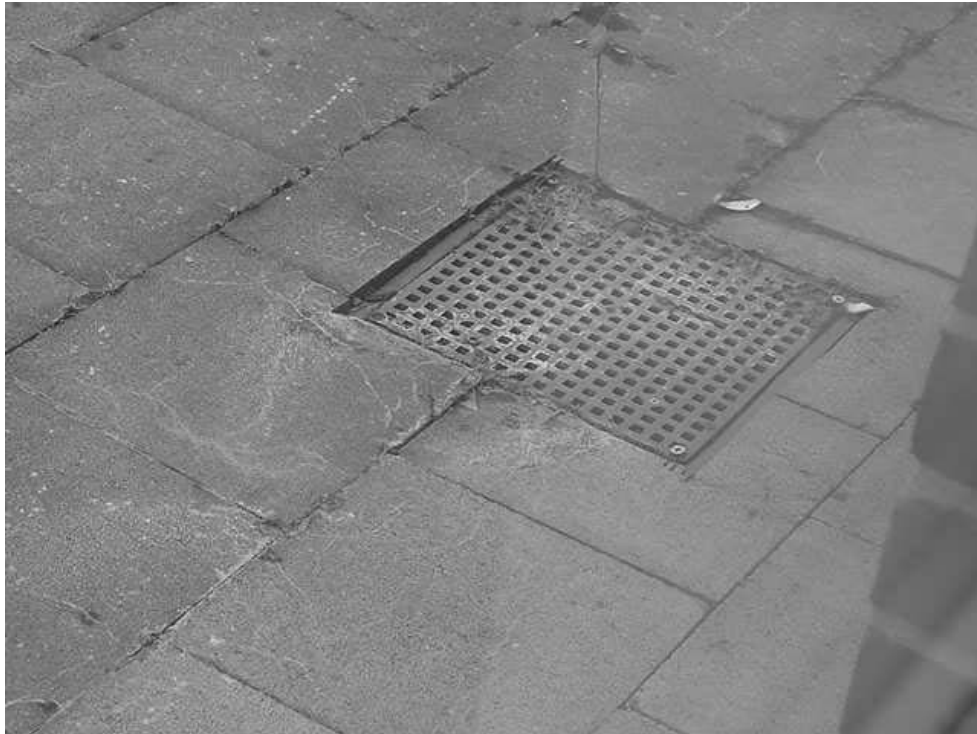
Picture 11

Roof Drain on 5th Floor Concrete Block Deck

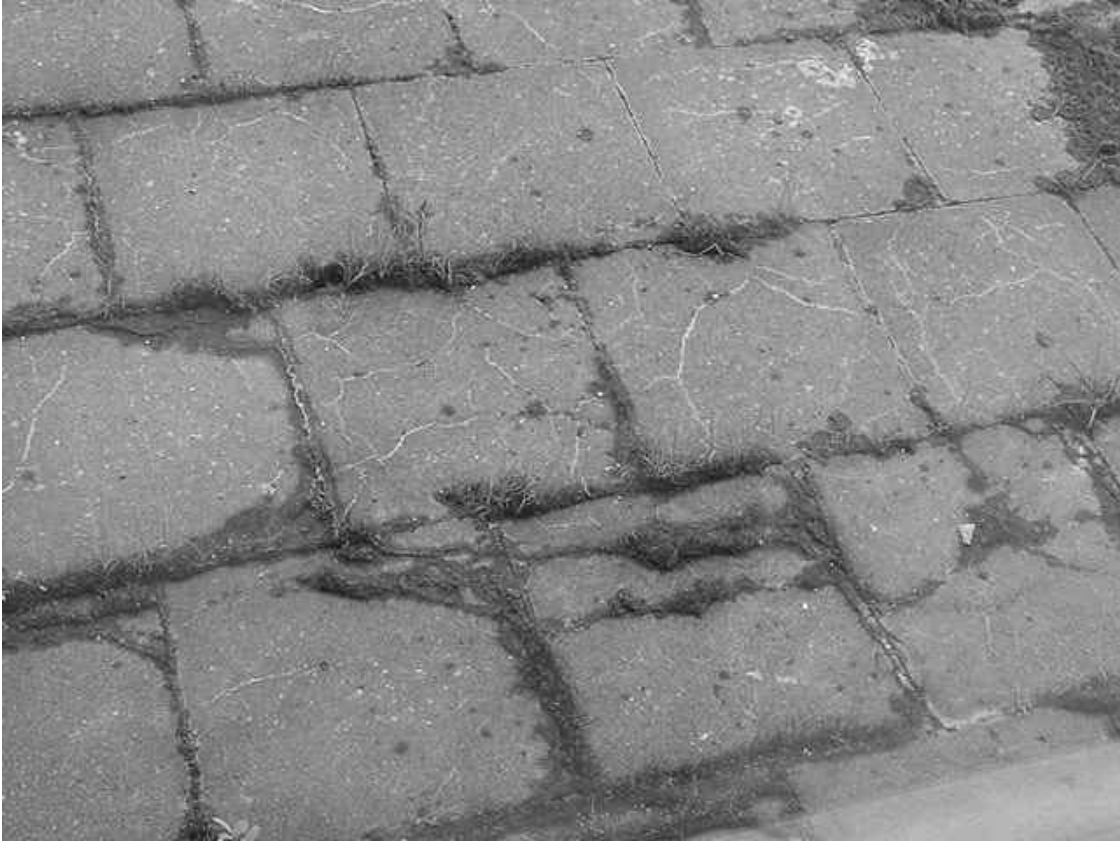
Picture 12

Moss/Plant Growth between Concrete Blocks 5th Floor Deck

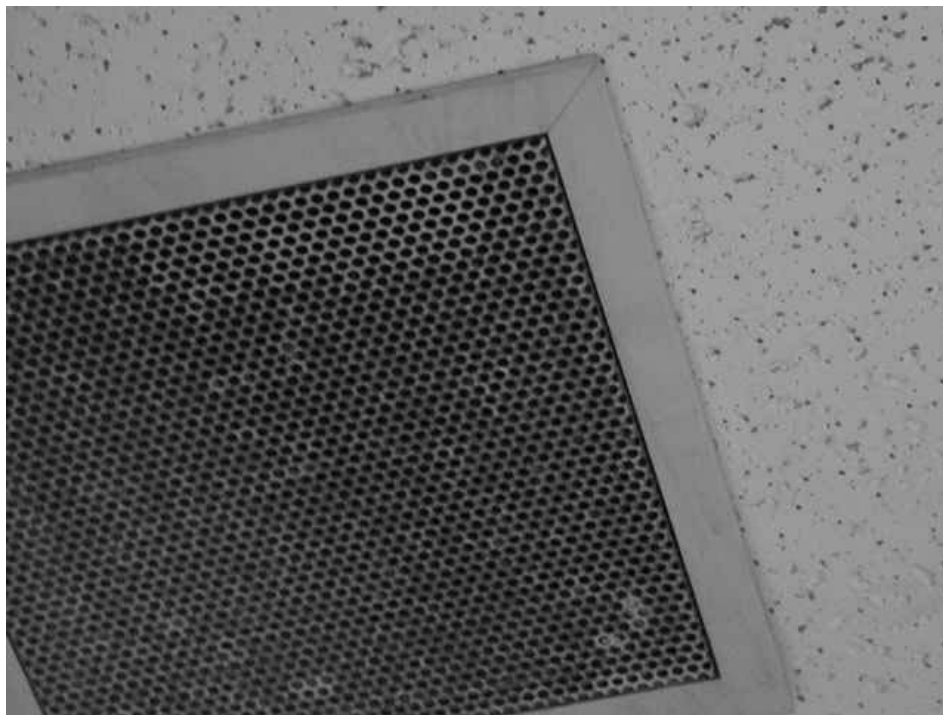
Picture 13

A number of supply and return/exhaust vents had accumulated dust (Picture 13). If exhaust vents are not functioning, backdrafting can occur, which can aerosolize dust particles. In addition, these materials can accumulate on flat surfaces (e.g., desktops, shelving and carpets) in occupied areas and subsequently be re-aerosolized causing further irritation. Dust can be irritating to eyes, nose and respiratory tract.

Dust Accumulation on Ceiling-Mounted Return Vent

9. Clean supply and return/exhaust vents periodically of accumulated dust.
10. Refer to resource manuals and other related indoor air quality documents for additional building-wide evaluations and advice on maintaining public buildings. These materials are located on the MDPH's website: http://mass.gov/dph/indoor_air.

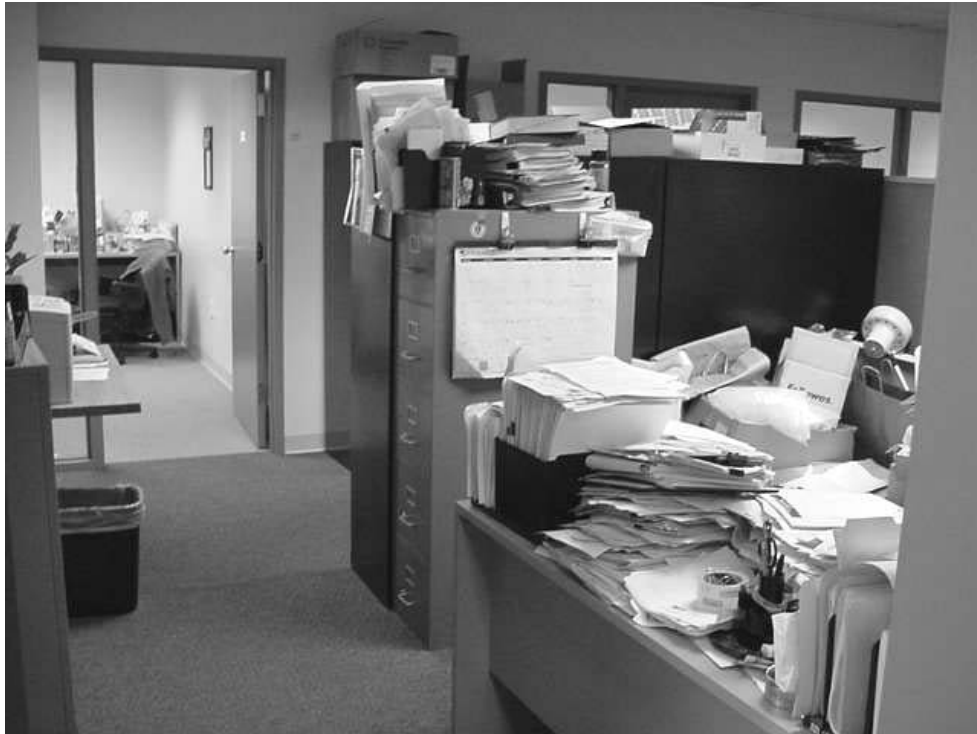
Picture 14

Finally, of note was the amount of materials stored in cubicles, open areas and inside offices (Picture 14). In areas throughout the building, items were observed on windowsills, tabletops, counters, bookcases and desks. The large number of items stored provides a source for dusts to accumulate. These items (e.g., papers, folders, boxes) make it difficult to clean. Dust can be irritating to eyes, nose and respiratory tract. Items should be relocated and/or be cleaned periodically to avoid excessive dust build up.

Accumulated Items in Open Area

8. Relocate or consider reducing the amount of materials stored in cubicles, office and common areas to allow for more thorough cleaning. Clean items regularly with a wet cloth or sponge to prevent excessive dust build-up.
